DOCUMENTATION AND ARCHITECTURAL ANALYSIS  
OF LITTLE MANOR PLANTATION HOUSE

William Luby Ferguson

A THESIS

Historic Preservation

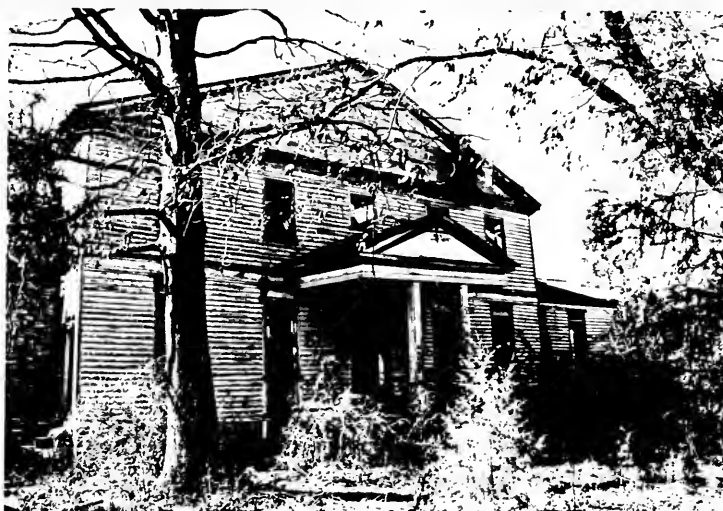
Figure 2: North Elevation

Little Manor is isolated, being in woods where there is no viable access road or functioning utility services. It has been in a steady state of physical decline for the last fifty years and has been deteriorating at an accelerated rate since last occupied in the 1960s. It has been vandalized and now is totally neglected. In the 1940s, the building was documented by noted photographer Frances Benjamin Johnson and studied by architectural historian Thomas Weston Waterman. In 1964, architecture student L. Scott Garner of North Carolina State College (now University), assisted by other students, documented the building with measured drawings. The timing of the latter survey was fortunate, for since that time major sections of the Federal main massing have deteriorated, the east wing chamber has collapsed, all the porches except the main portico are gone, and all doors and window sashes and most of the interior ornamental details have been vandalized or removed. The photograph below shows a view of the north elevation in its current condition. The chimney on the left is the only surviving component of the east wing chamber, the structural integrity of the main massing is tenuous at best, and the main portico is supported by only its two inside square columns.

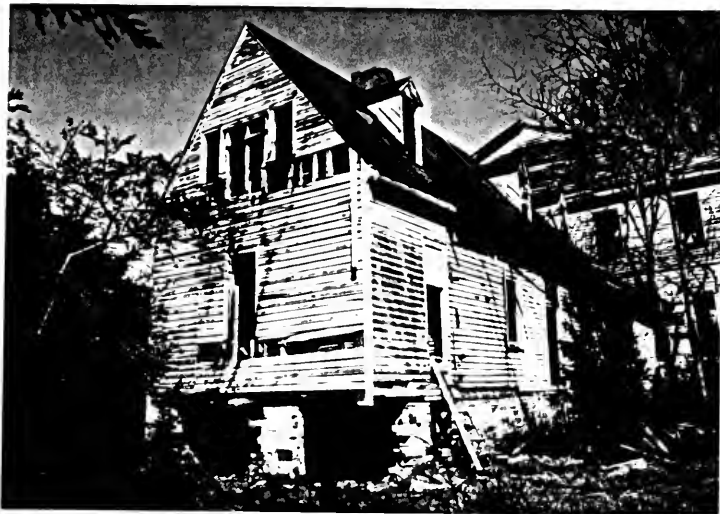
Figure 3: South and East Elevation of the Georgian Section

The Georgian section, at the south or rear elevation, has fared better, but as seen in Figure 1 at the top of the next page, it has lost its foundation at the southeast corner and weatherboard has peeled off the south gable and below the eaves of the east elevation.

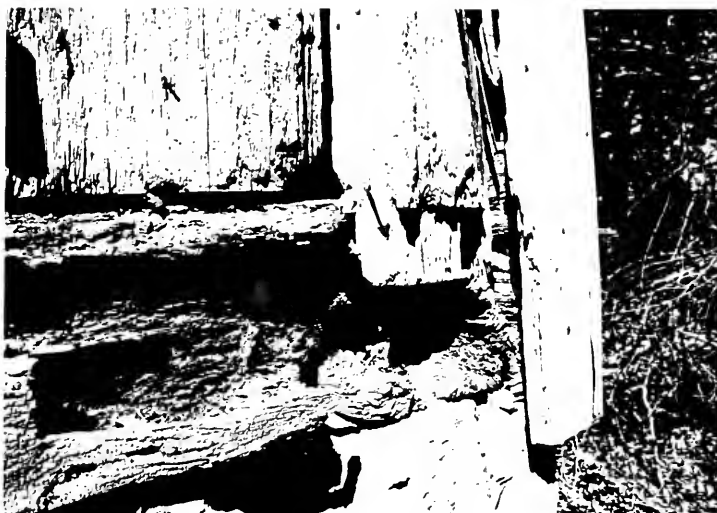
Figure 15: Federal Section Northeast Corner Connection

The complexity of the corner post and sill connections are shown in Figure 15. The photograph is taken at the northeast corner of the Federal section. The rotted sill (center left) is a twelve-by-twelve which receives the tenon of the corner post. A second mortise and tenon joint is located at the intersection of the east sill and the north sill, but this is not visible. In addition to having hidden joints, these connections were also difficult to analyze because the sills and plates differ in size and in the planes of their connections. This is illustrated in the oval shown at the northwest corner of the north elevation drawing. The vertical cross section member (center left in oval) is the west second floor top plate, a four-by-twelve. It is mortised and tenoned into the massive north plate and rises three inches above it, to the same level as the top of the joists.

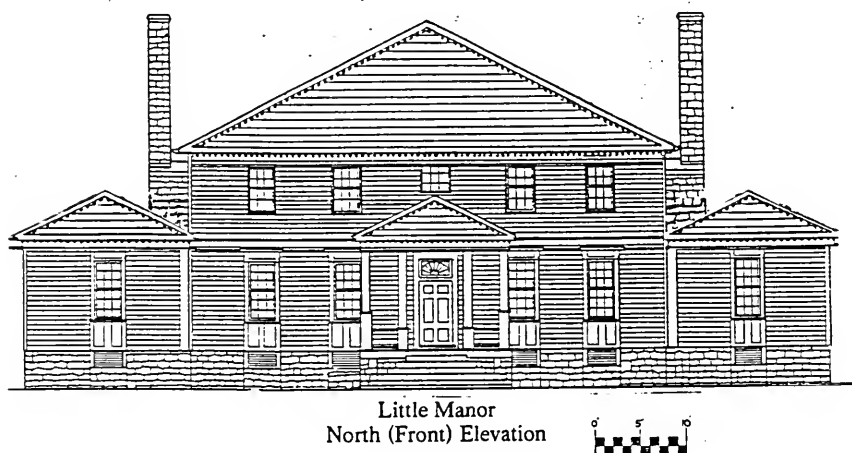
Figure 83: Original Design of Federal North Elevation

Although visually pleasing, the problem with the design is that during rain storms heads of water rush down the roof surfaces of the gables directly onto the chimney and weatherboard of the side elevations of the main massing. Unless very large valley gutters or wide metal flashing materials are used, there is no way the water is prevented from splashing onto the weatherboard and into its overlapping seams. Heads of water can also penetrate into the mortar joints of the chimneys. The result is that these vulnerable areas began to deteriorate rapidly, and the owners were forced to solve the problem by rotating the roof structure to its current form so the flow of water ran off the eaves down onto the ground or into a gutter.

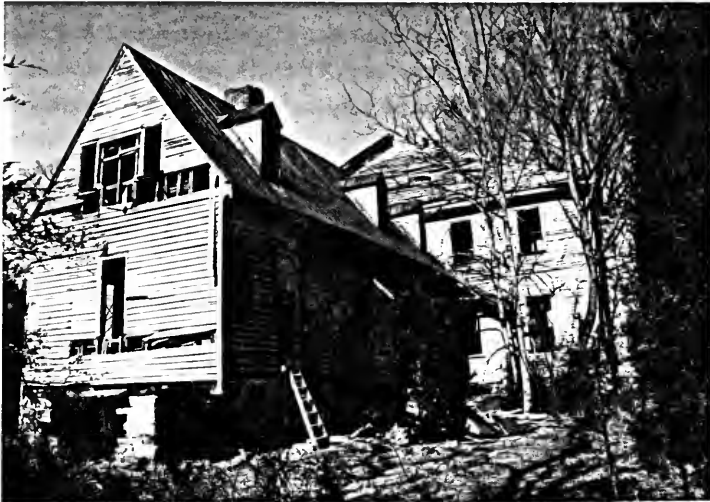
Figure 85: Loss of Fabric at Southeast Corner of Georgian/cross hall Section

The main causes of deterioration to Little Manor are water penetration, brown rot fungi and most of all, human neglect. Beginning with the foundation, there are two main issues, loss of fabric and flooding. Foundation loss is greatest in the Georgian/cross hall section. Shown in Figure 85, taken from the southeast, all of the foundation has collapsed at the southeast corner. A similar situation has occurred on the west elevation where the cross hall meets the Federal main massing.

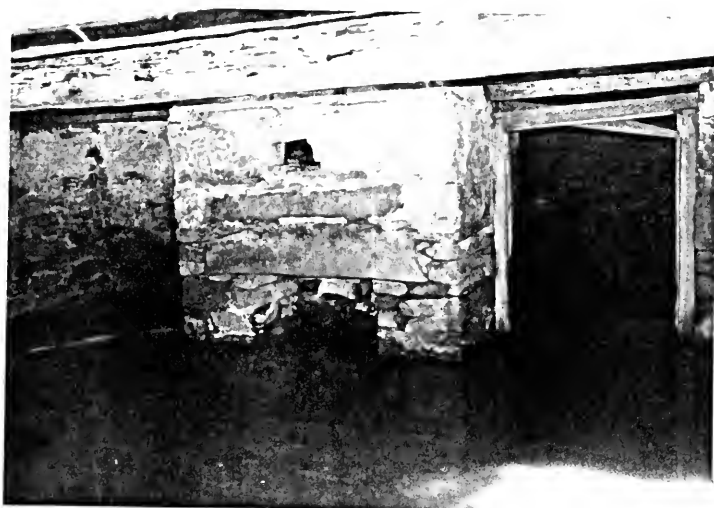
Figure 86: Flooded Basement under Georgian Parlor

Although the basement the Federal main massing is fairly dry, the basement spaces beneath the Georgian hall and parlor are in a constant flooded condition, being the lowest areas below grade. Seen in Figure 86, under the Georgian parlor, there is one to two feet of stagnant water.

performing this task, the water in the Georgian basement needs to be drained. At the south elevation, a two foot trench could be dug and the water could drain out where the grade slopes down and away from the building.

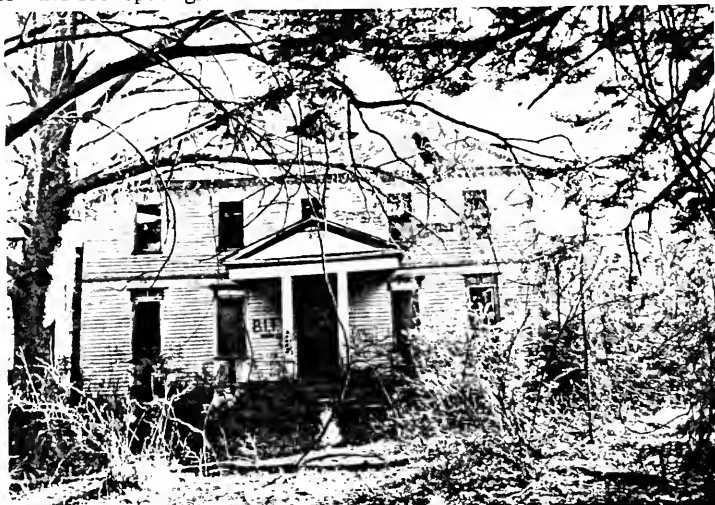
Figure 87: North Elevation Damage

The next three figures show the overall damage to the building's horizontal envelope. Figure 86 shows the Federal north elevation. The east chamber is gone, square columns and foundation elements of the portico are missing, there are holes in the weatherboard and no protection over the window and door openings.
